Greenville-Spartanburg Int'l Dovetails Ramp Replacement With Terminal Rehab

Project: Apron & Trench Drain Reconstruction

Location: Greenville-Spartanburg (SC) Int'l Airport

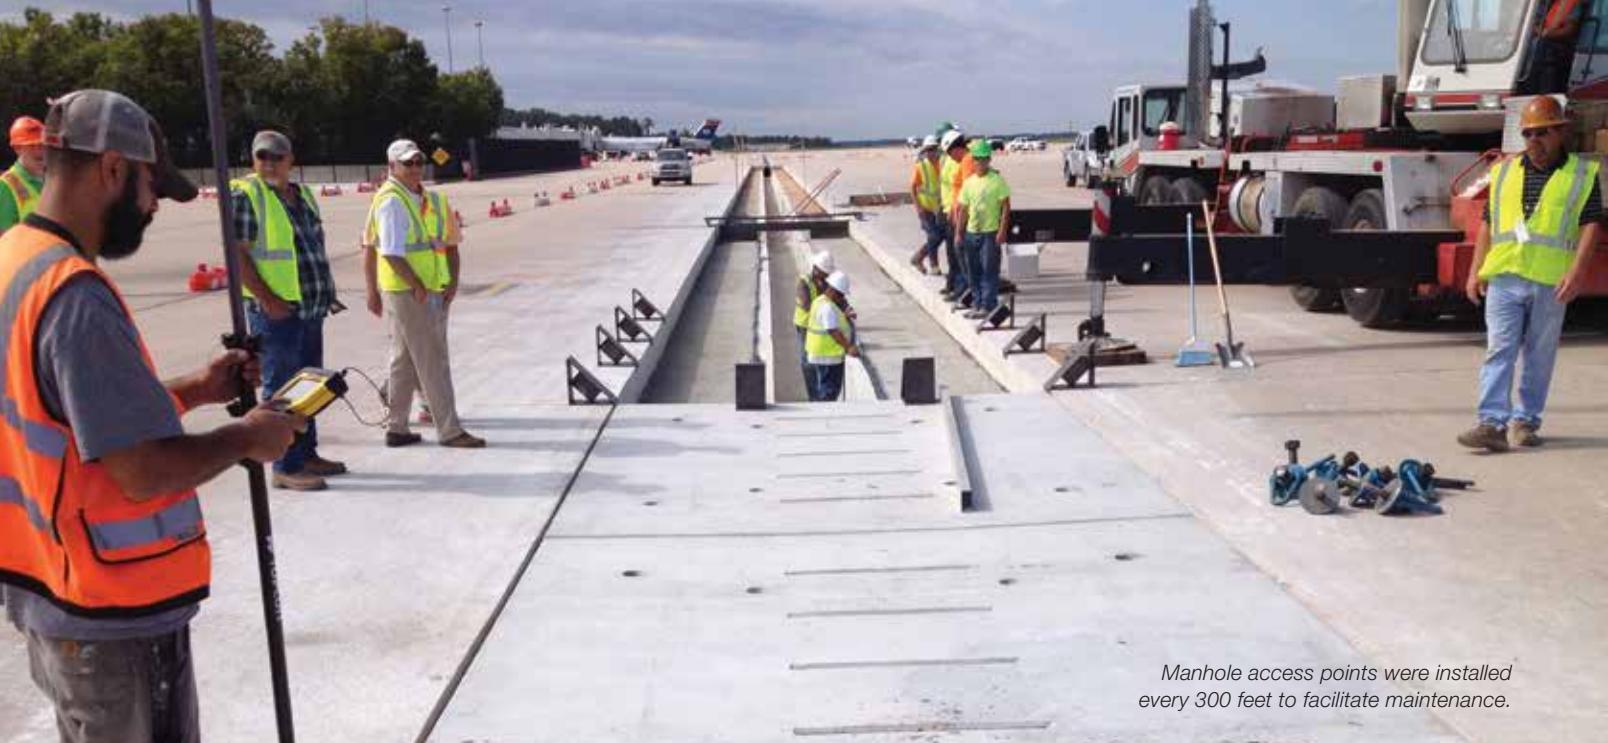
Manhole access points were installed every 300 feet to facilitate maintenance.
